Return to Sherlock Creek: An Exploration of the Old Johnny Marshall Gold Mine, Mariposa Co., California

by
Warren B. Carah

©2010 by Warren B. Carah
11464 Eagle Way
Brighton, MI 48114-9019
Illustrated Edition—Rev. 0--22 June 2010

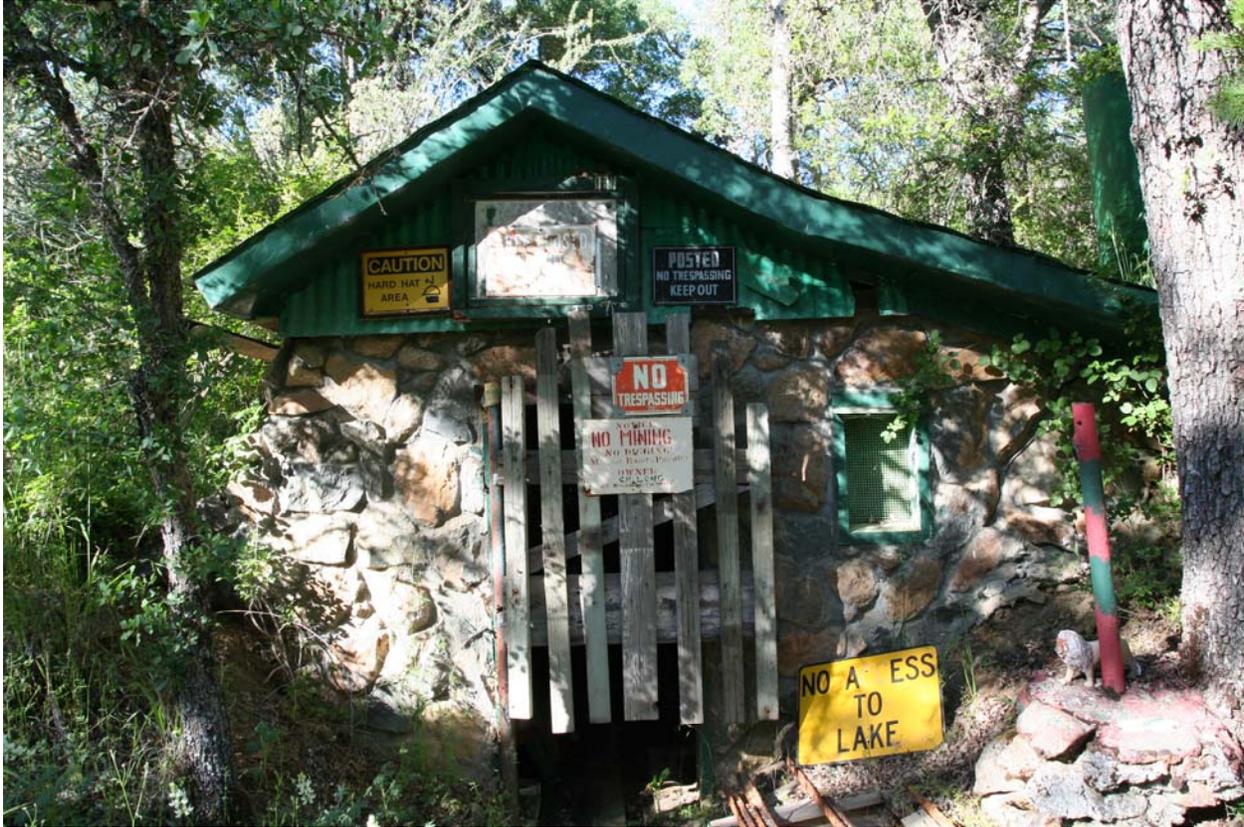
The Entry Vestibule to the Marshall Mine on Sherlock Creek, Mariposa County, California. Photo by W.B. Carah

The current mine entrance consists of a mortared flagstone faced building or vestibule with a trussed gable roof. The vestibule is about 15 feet long and 10 feet wide and is some 12 feet in height. The outside entrance to the vestibule is secured by a somewhat dilapidated wooden slat door. Inside the vestibule, a more substantial door lies against a wall, apparently abandoned.

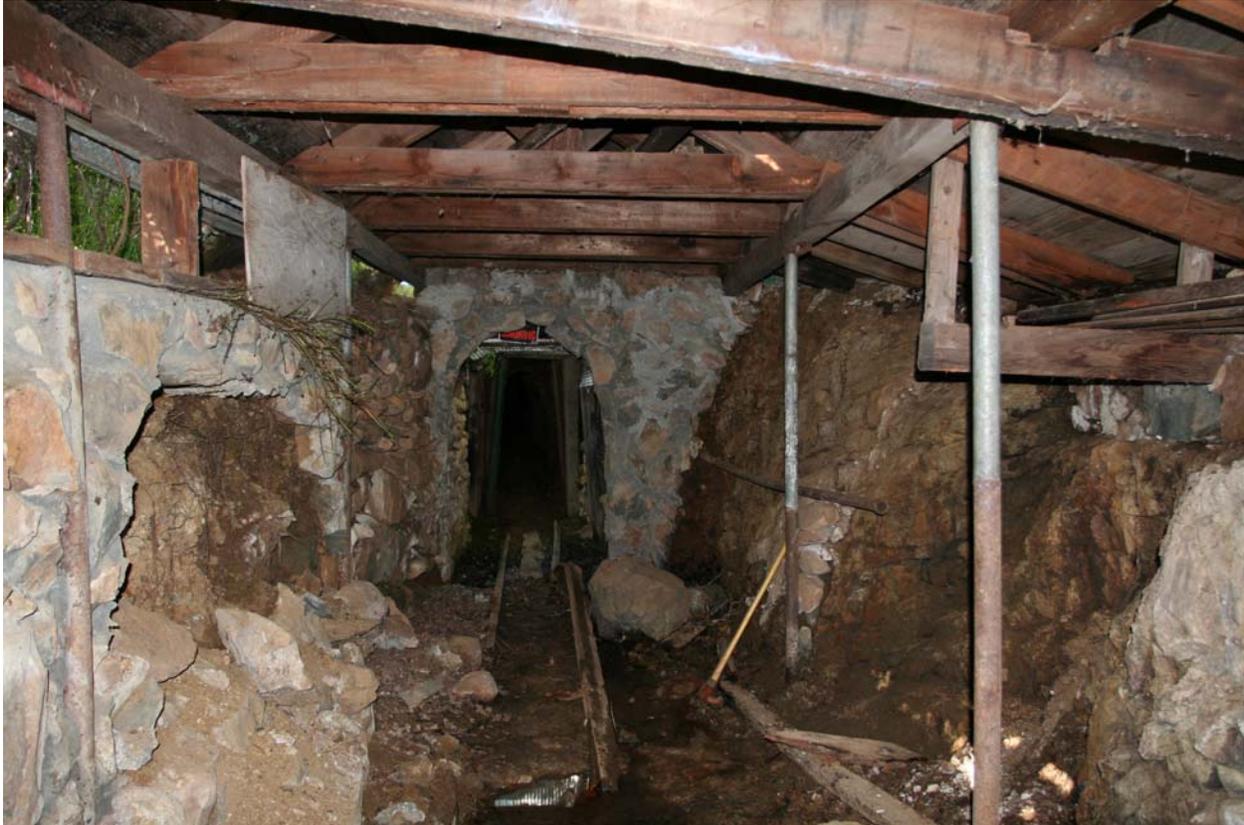
View of the Marshall Mine Entry Tunnel from Inside the Vestibule. Photo by W.B. Carah

At the southeast end of the vestibule is the mine entrance proper. It consists of a narrow shaft about four feet wide and six feet tall. It is shored with tree trunk timbers about every 15 feet. On the mine floor there is a narrow gauge rail installation for the movement of ore carts.

Approximately 30 feet into the mine, the shaft splits into two tunnels. The shaft on the left is the original Marshall excavation and originally ran some 800 feet into the hill according to the land owner. The shaft on the right goes in a southeasterly direction and is of newer vintage. The newer shaft is partially shored with cast concrete uprights and cross ties. There is strong evidence that the older tunnel has completely collapsed in places. The land surface approximately 150 feet to the northeast of the mine entrance, and in line with its projected shaft course, is heavily dimpled indicative of a collapsed tunnel below the surface.

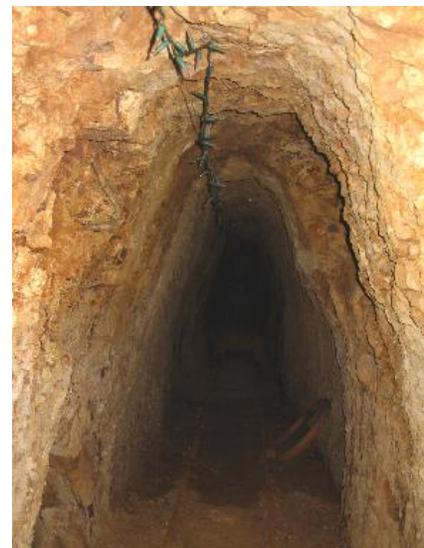
Right: View Down a Shaft at the Marshall Mine

It appears that the original shaft turns a bit to the southeast and run upwards, whereas the newer shaft runs more northeasterly and a bit downwards. The result is that the vintage shaft actually crosses over the top of the newer shaft about 50 feet into the mine. It was eerie to look up at the ceiling of the newer shaft and see that heavy wire mesh was installed on what was once the floor of the old shaft. Looking through the wire mesh, one could see the ceiling of the original mine some 12 feet above. During my visit, the mine was heavily populated with bats and some rats, but they were more interested in fleeing the intruders than in confrontation.

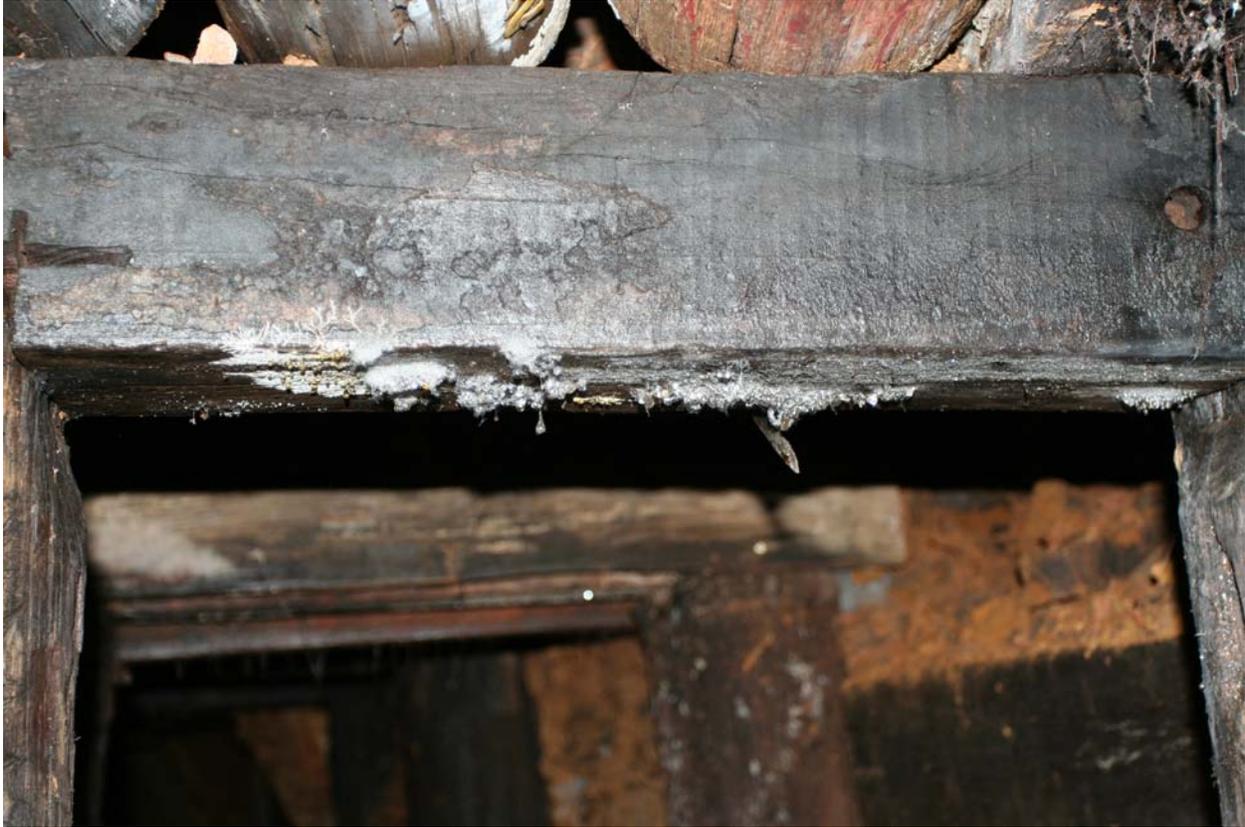
View of the Marshall Mine Shoring. Note the Peg Type Connection Between the Cross Tie and Vertical Support. Ceiling Shoring Is Made from De-barked Logs. Photo by W.B. Carah

The newer and older shafts exhibited signs of cave-ins, tree root intrusions and water seepage. The mine walls consist of unconsolidated cobbles and angular rocks averaging 10-12 inches in length. The rock color was yellow with dark spotting. Most of the rock face was moist and the surrounding soil was muddy and sticky in texture. The floor had some standing water in places. Wall and roof shoring was fairly widely spaced—some 15 feet between uprights and cross ties. In the original mine, the shoring was made from debarked tree trunks approximately 10 inches in diameter. The shoring in the newer mine was also

wood, but supplemented with modern concrete-like materials. It appeared that the main force holding up the walls and roof was the friction and mechanical locking together of the rock pieces.

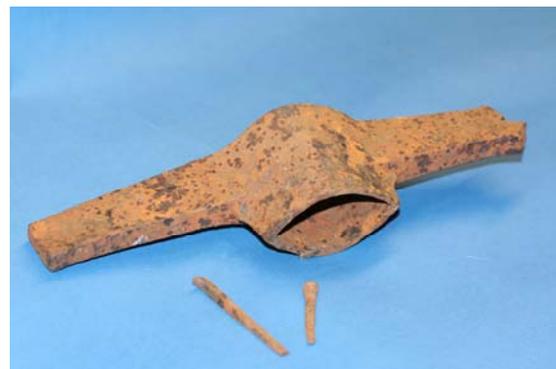
Artifacts from the Marshall Mine—Pick Head and Square Nails. Photo by W.B. Carah

Numerous artifacts have been found in and around the mine by the owner, including damaged picks, shovels, metal straps, hardware, bolts, and numerous square nails. There is also a very old well with a hand pump on the west side of the creek that appears to be original.

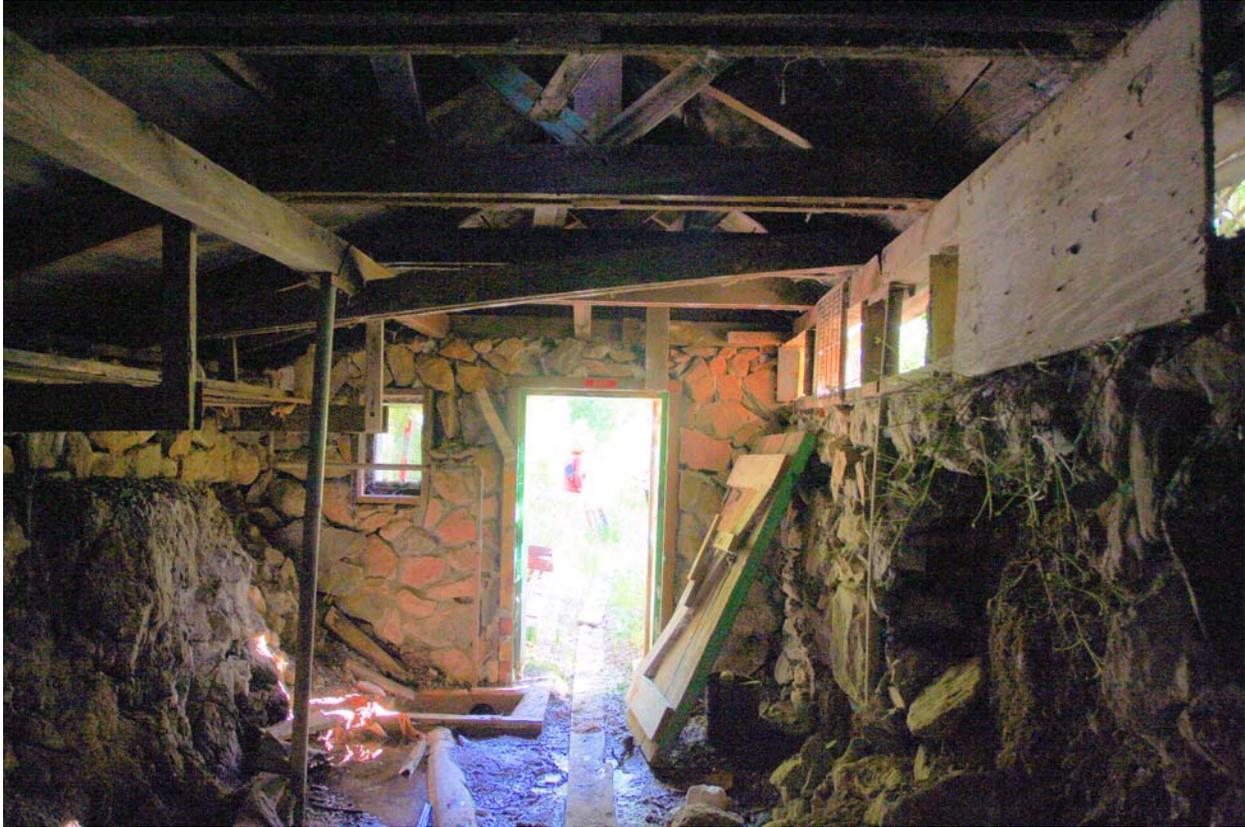
View Looking from Inside the Mine Shaft to the Entry at the Vestibule. Photo by W.B. Carah

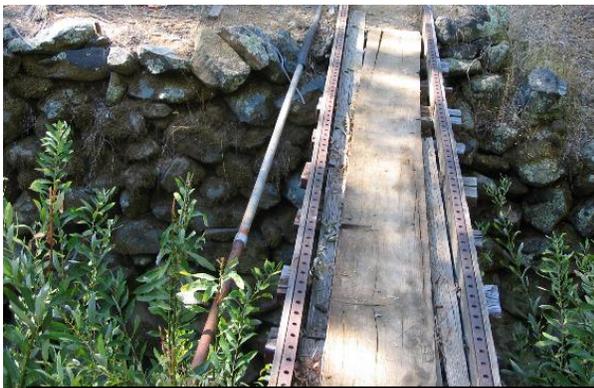
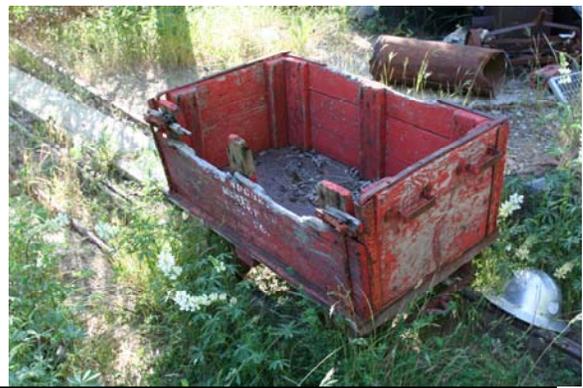
Left: Rails Bridging Sherlock Creek About Five Feet Above Bed. Note the Stone Dressed Stream Bank. Right: Ore Cart on the Rails to Move Rock from the Mine to the Sluice Box Across Sherlock Creek.

A narrow gauge rail system for ore carts is evident in the old mine extending out of the entrance and bridged over to the west side of Sherlock Creek. There, at the west side of the creek, the rails turn northwest and extend about 15 feet and terminate at a raised platform above the creek bank.

Here, it is likely the Marshall's had installed a sluice box to wash the rock and settle out the heavier gold. The current land owner has a modern version of a sluice box installed right where the old one would have been located. The banks of Sherlock Creek around this sluicing operation were lined with dressed, but un-mortared stone for some distance up and

down the stream. The stone bank walls above the creek average some five feet above the bed. Approximately 35 feet upstream from the mine, it appears a pool was constructed on the creek to reservoir water for mining operations and was likely pumped or fed by gravity to the sluice box.

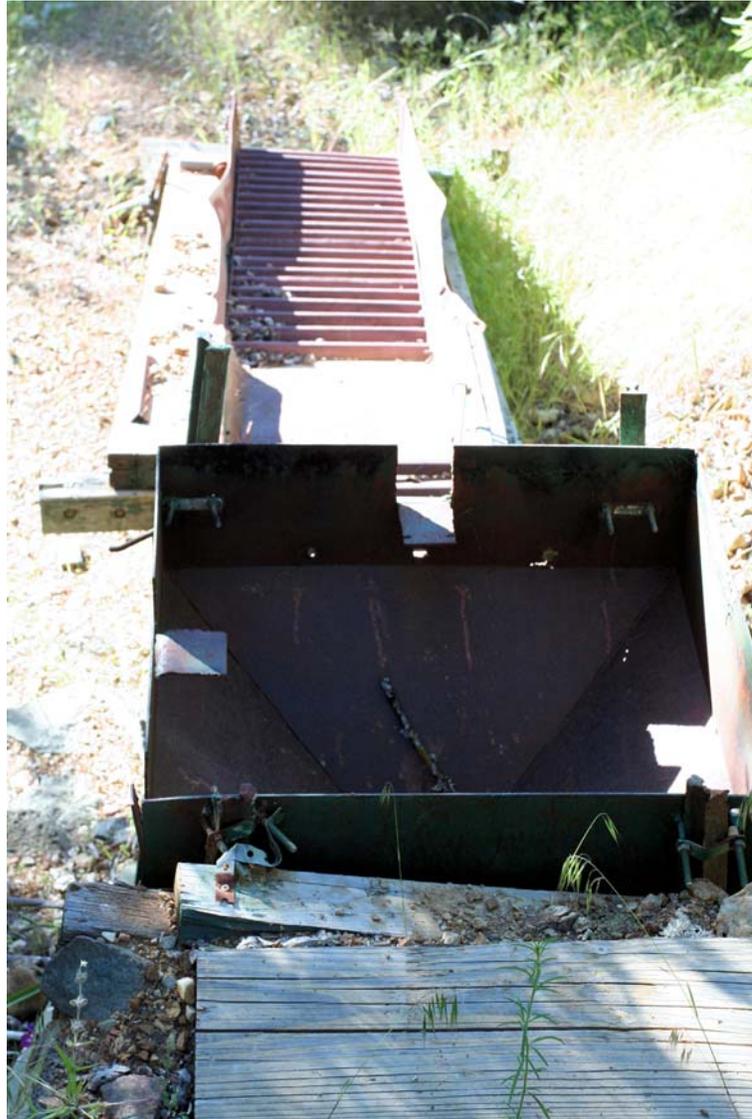
Modern-day Sluice Box in Place at the Marshall Mine. It is Probable a Similar Gold Sorting Device was Located in the Same Place Next to Sherlock Creek in the 1850's. Photo by W.B. Carah

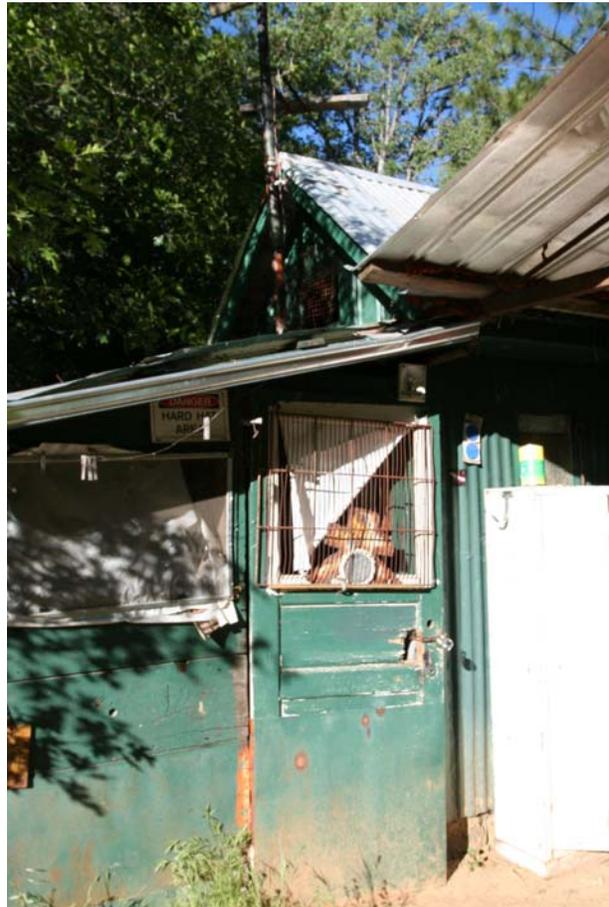
Approximately 15 feet south of the mine entrance on the east side of the creek is a shed like building which serves as a storage place and outhouse and might have once been a dwelling. The structure has been much modified over the years and it is difficult to determine its original size or construction. The extended Marshall family and their laborers constituted a fairly large group of people, so a house structure(s) would have to have been sizeable. Like much of old Sherlock, the house was likely cannibalized over the years for materials for use in the mines.

**Right: This Utility Building Next to the Marshall Mine May Have Once Been a Dwelling.
Photo by W.B. Carah**
